United States Department of the Interior National Park Service National Register of Historic Places Registration Form

Historic name: Baker Brothers Wholesale Grocery
Other names/site number: N/A
Name of related multiple property listing:
N/A
(Enter "N/A" if property is not part of a multiple property listing
2. Location
Street & number: 8-12 East Main Street
City or town: <u>Zanesville</u> State: <u>Ohio</u> County: <u>Muskingum</u>
Not For Publication: NA Vicinity: NA

Baker Brothers Wholesale Grocery Name of Property Muskingum County, Ohio County and State

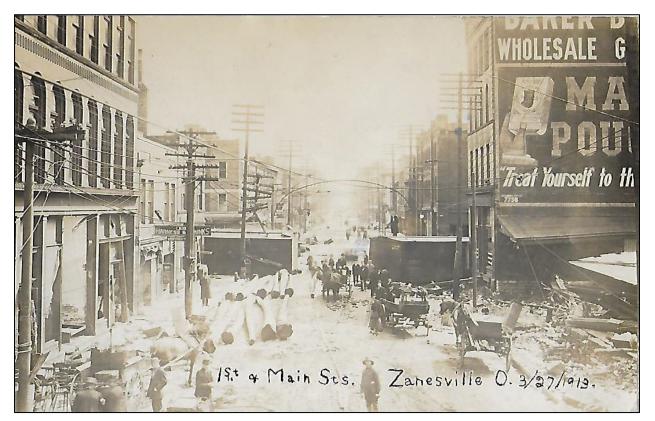
Figure 15. Photograph of the 1913 flood showing the west wall of the original 1894 building painted as a billboard at right.

Historic photographs (Figure 15) show that the west side elevation originally had no window openings and acted as a large billboard for painted advertisements. When the 1913 addition was constructed, multiple openings were made on the second floor to allow passage from the addition to the original building. Mr. Jeffrey Rose, whose company once owned and occupied the 1913 addition and 1978 addition, remembers that the owners and employees of each half were on the honor system to not enter each other's space without permission. Sometime in the 1980s, these openings were infilled with brick.¹

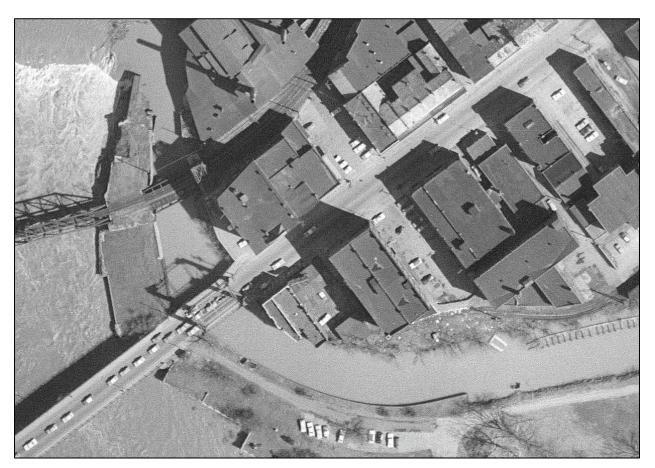
Figure 19. Detail from 1966 aerial photograph showing the original 1894 building and the 1913 addition in the center just north of the canal.

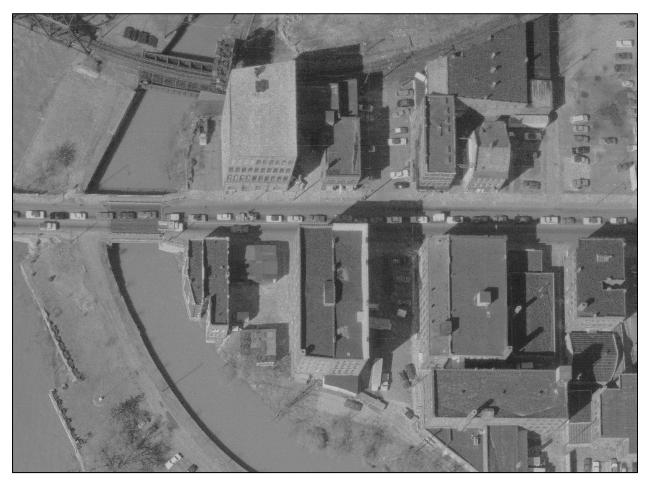
Figure 20. Detail from 1977 aerial photograph showing the original 1894 building and the 1913 addition in the center.

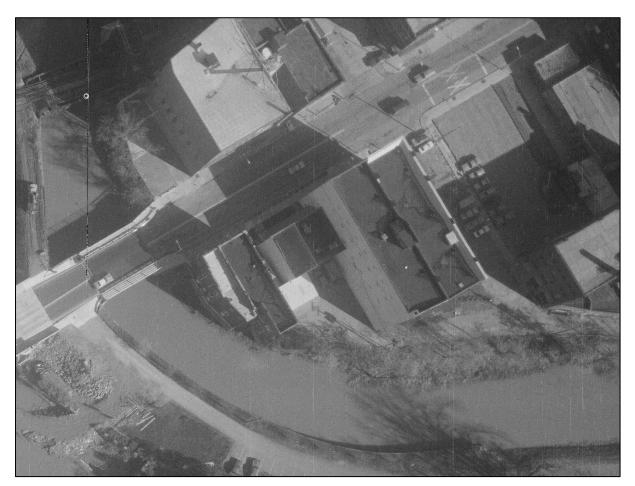
Figure 21. Detail from 1984 aerial photograph showing the original 1894 building, the 1913 addition, and the 1978 addition.

The one-story room in the rear made of concrete block with a greenhouse rear wall does not appear on an 1984 ODOT aerial photograph (Figure 21) and was likely added to the building during renovations that occurred in the early 1990s (Photo 22). The upper floors of the 1913 addition were converted into offices (Photo 25). To support the modern commercial use, two new egress stair towers have been built: one along the rear elevation and one perpendicular to the west elevation. The rear stair addition covered original window openings, but they are intact and clearly visible from the stairwell (Photo 34). The west stair does not access the first floor of either building. Access to the second floor of the 1978 addition is made by stairs built along the south wall, parallel to the west stair tower and a short stair along the north wall. Enclosed by a door, the short stair flight provides access from the second floor of the 1978 addition into the second floor of the 1913 addition (Photo 23). The steel columns on the second floor have been encased in drywall but the timber joists and exterior brick walls remain exposed (Photos 23 and 24). The original wood plank floors can be seen in a few utility rooms but have largely been covered with carpet. The second floor of the 1978 addition is partitioned into offices and classrooms, which have carpeted floors and acoustic tile ceilings (Photos 26 and 27).
